INSPECTION REPORT

For the Property at:
123 SOMEWHERE STREET
MY TOWN, ON

Prepared for: JOHN & JANE SMITH
Inspection Date: Thursday, March 3, 2016
Prepared by: Jeff Rockburn, RHI, NCI

RE: Report No. 1001
123 Somewhere Street
My Town, ON

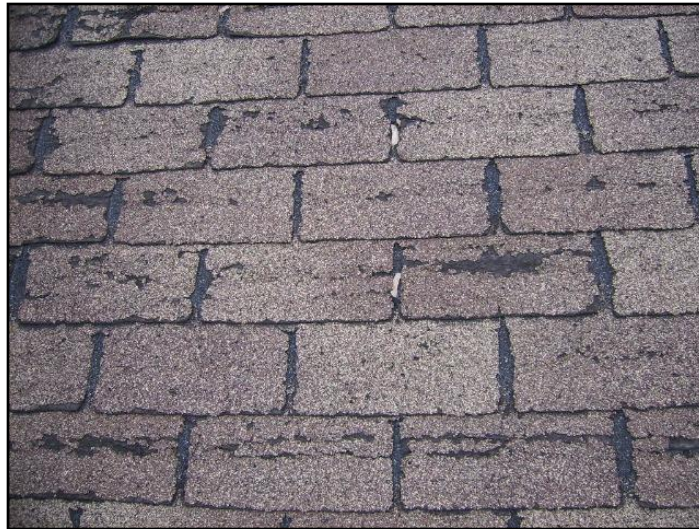
1. *Old, worn out*

1. Condition: • [Old, worn out](#)

Implication(s): Chance of water damage to contents, finishes and/or structure

Location: Throughout

Task: Replace

Time: Less than 2 years

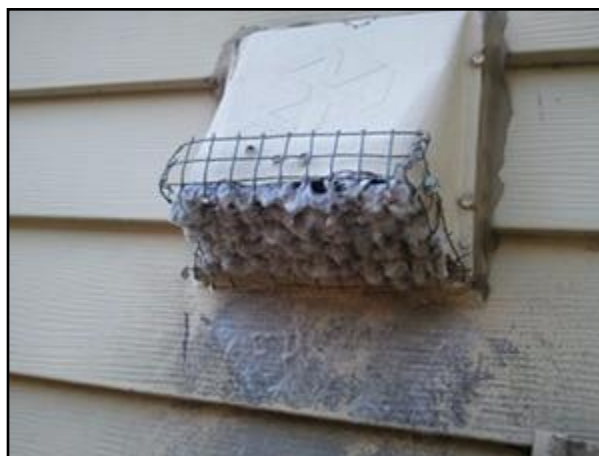
2. Dryer vent requires immediate and regular...

- 2. • Dryer vent requires immediate and regular cleaning

Location: Back Exterior Wall

Task: Perform Maintenance Clean

Time: Immediate action required

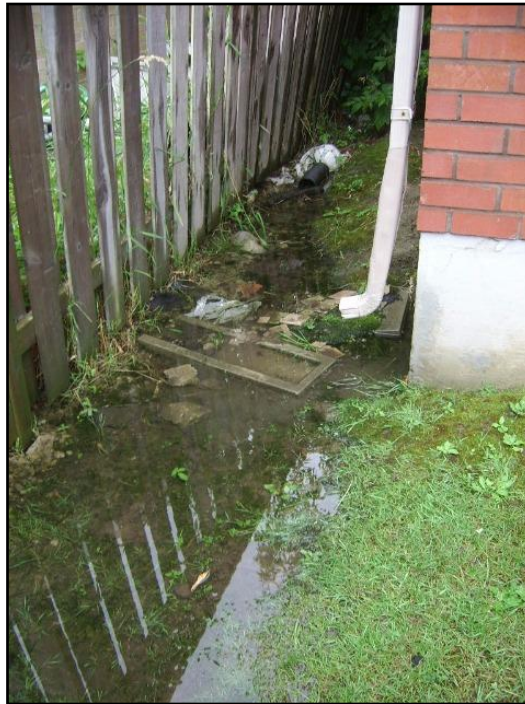
3. Condition: • [Downspouts end too close to building](#)

Implication(s): Chance of water damage to contents, finishes and/or structure

Location: Rear Left

Task: Improve

Time: Immediate

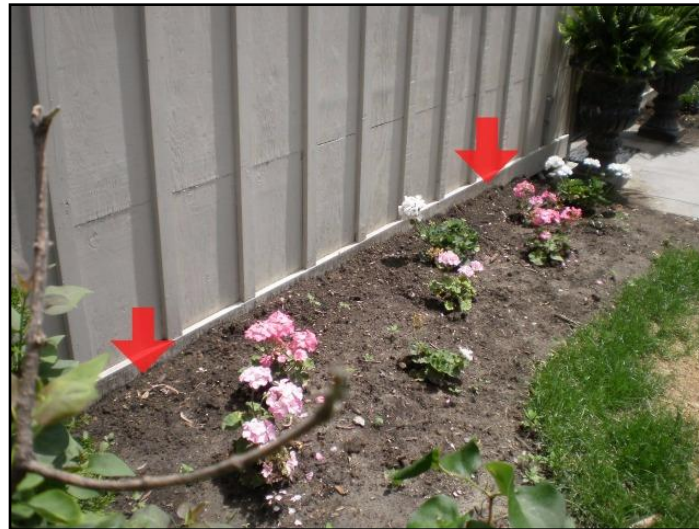
4. Condition: • [Should discharge 6 feet from building](#)

Implication(s): Chance of water damage to contents, finishes and/or structure

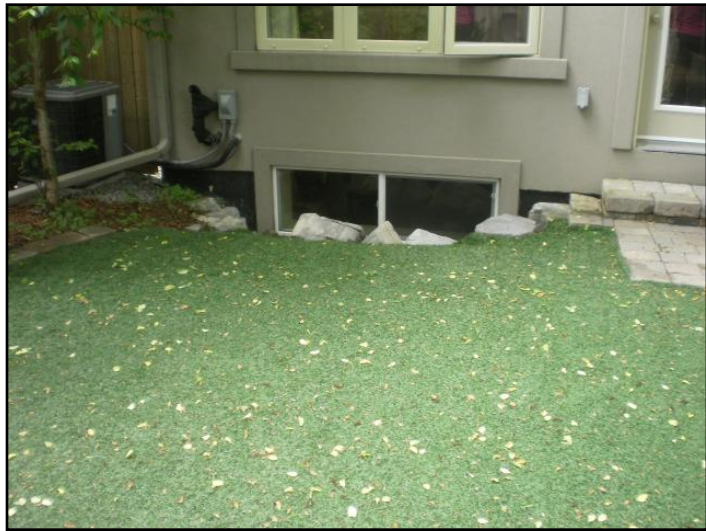
5. Condition: • [Too close to grade](#)

Implication(s): Chance of water damage to contents, finishes and/or structure | Material deterioration | Rot | Insect damage

Location: West Exterior

Task: Correct

Time: Less than 1 year

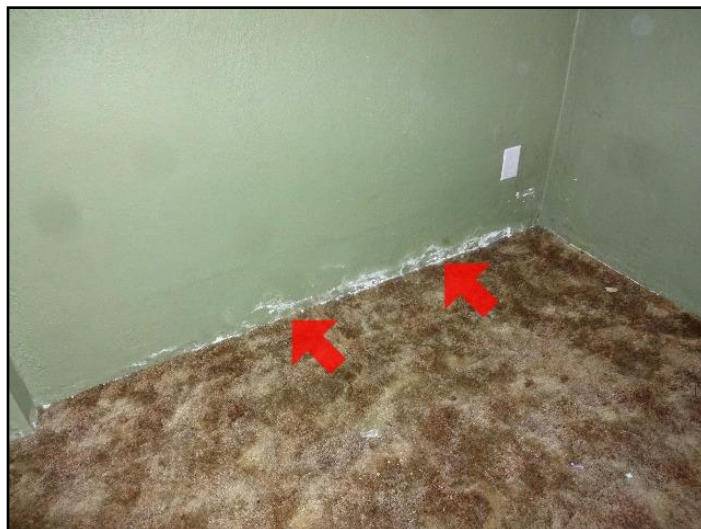
6. Efflorescence

7. Condition: • [Efflorescence](#)

Efflorescence is a product of moisture travelling through a masonry wall and depositing mineral deposits when it evaporates into the room. It is sometimes related to a leak but often indicates that the wall on the exterior is holding moisture or there is poor drainage in this area. Corrective measures on the exterior are usually recommended in this case.

Moisture from the floor slab cavity is also a common source of efflorescence along the foundation wall.

Implication(s): Cosmetic defects | Weakened structure

Location: Front Basement

Task: Improve existing condition- Monitor

Time: As soon as possible

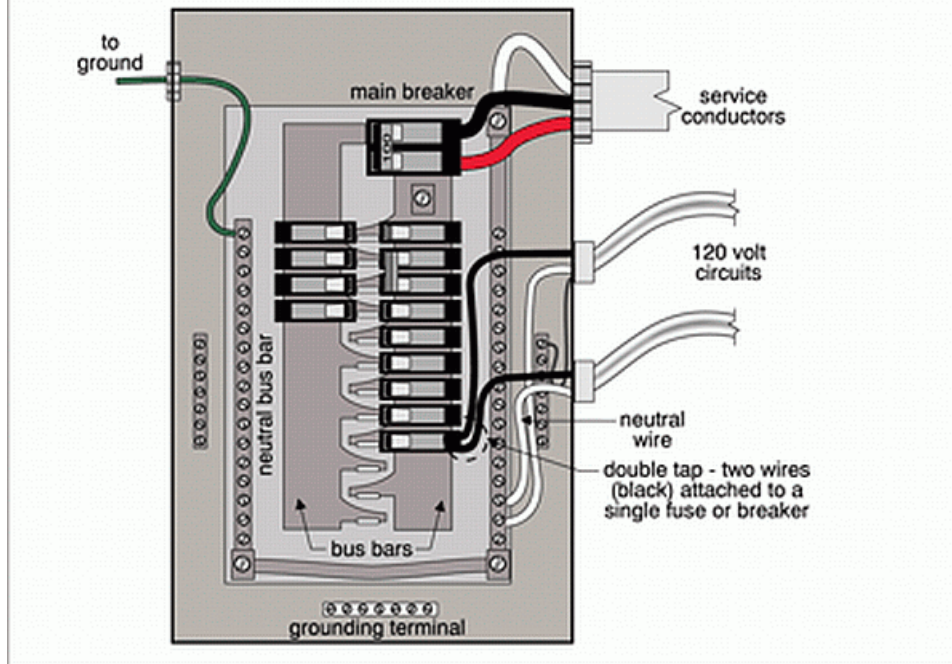
Double tapping (double lugging)

8. Condition: • [Double taps](#)

Improper connections on a double tap can cause arcing, overheating of wires and fire

Implication(s): Fire hazard

Location: Basement Electric Panel Area

Task: Further evaluation for remedial action recommended from a specialist in this field

Time: At the earliest opportunity

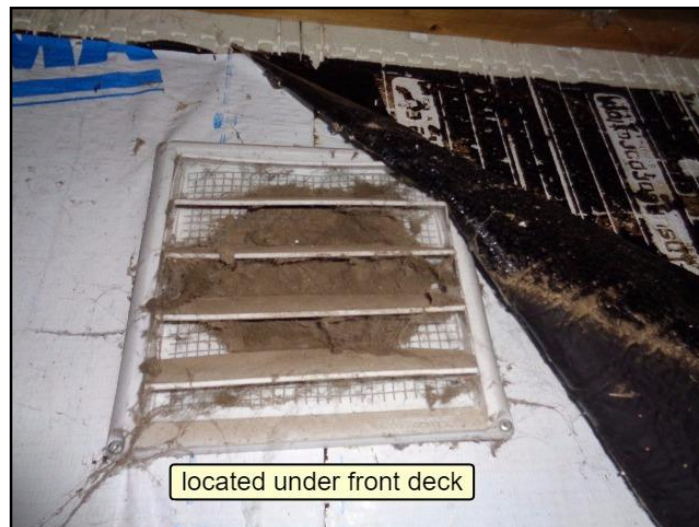
7. The grill for the fresh air intake is eithe...

11. Condition: • The grill for the fresh air intake is either blocked or damaged. It is important that this grill is maintained and kept free of debris so there is clean complete combustion of the furnace.

Implication(s): Poor operation of unit, incomplete combustion of furnace, possible CO production, health risks

Location: Front Exterior-under deck

Task: Clean

Time: Immediate and Regular maintenance

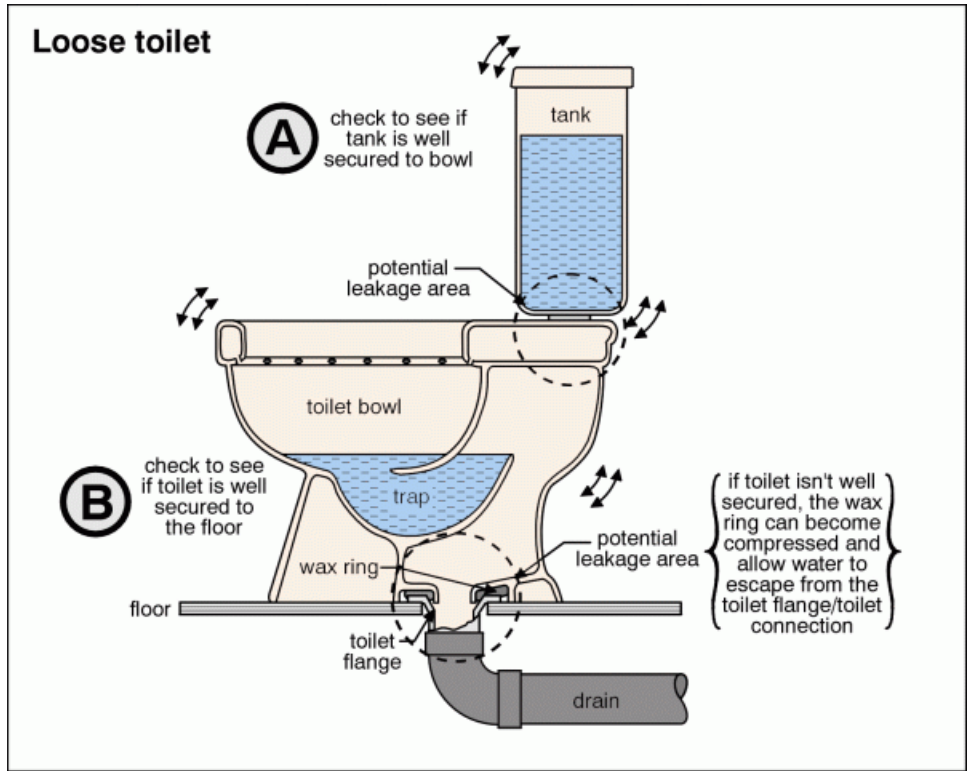
Loose toilet

18. Condition: • [Loose](#)

Implication(s): Chance of water damage to contents, finishes and/or structure | Sewage entering the building

Location: First Floor Powder Room

Task: Improve existing condition

Time: As soon as possible before condition worsens
