INSPECTION REPORT

For the Property at:
123 SOMEWHERE STREET
MY TOWN, ON

Prepared for: JOHN & JANE SMITH
Inspection Date: Thursday, March 3, 2016
Prepared by: Jeff Rockburn, RHI, NCI

RE: Report No. 1001
123 Somewhere Street
My Town, ON

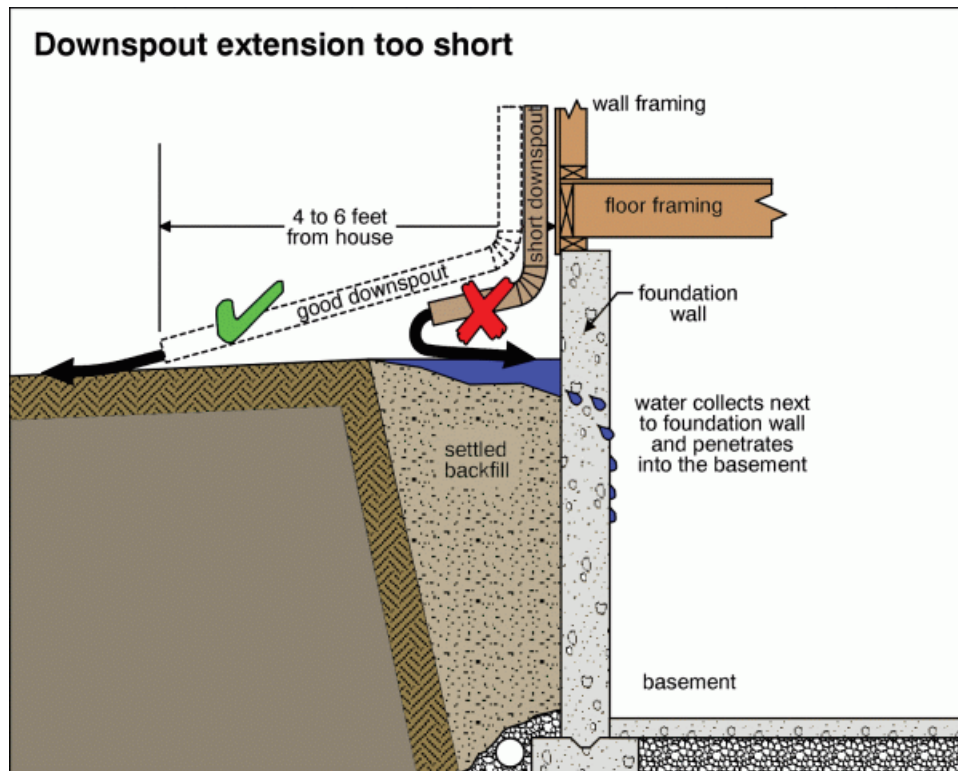
3. Condition: • [Downspouts end too close to building](#)

Implication(s): Chance of water damage to contents, finishes and/or structure

Task: Improve

Time: Immediate

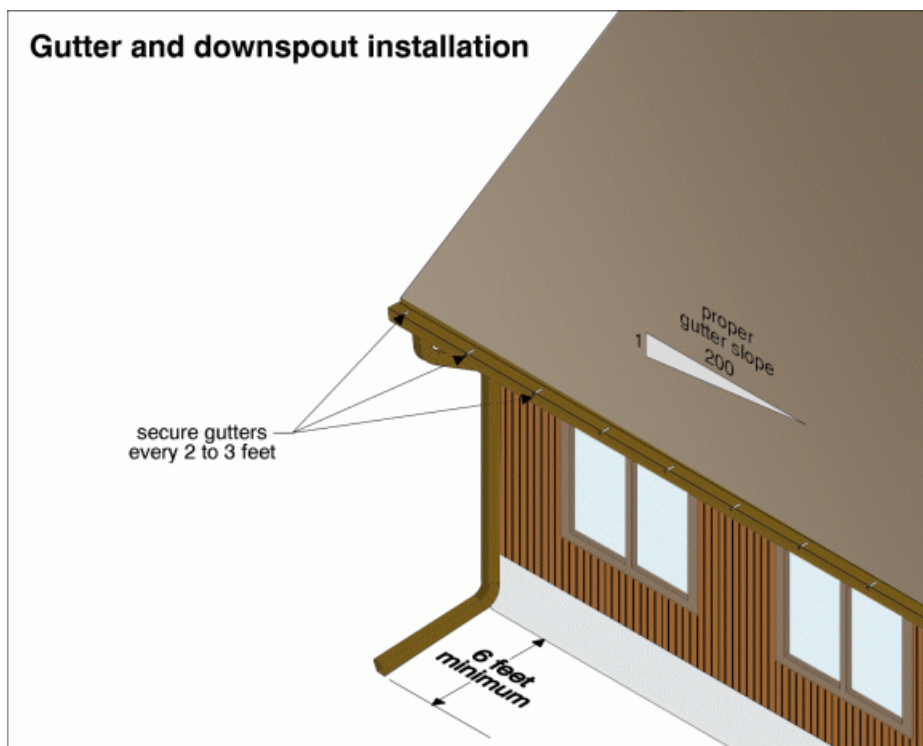
4. Condition: • [Should discharge 6 feet from building](#)

Implication(s): Chance of water damage to contents, finishes and/or structure

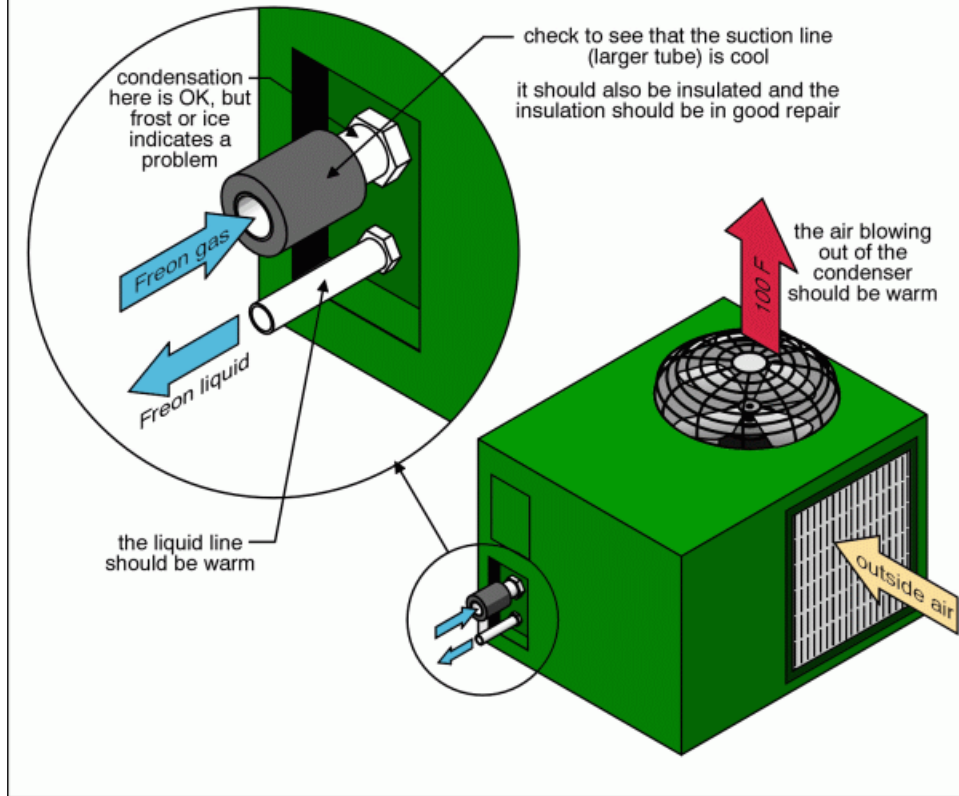
Inspecting the condenser unit
